# Manhole Inspection Summary

Manhole # S41QQ\_019MH

Insp Date: **2/20/07 1:06 PM**

**Location** Address: **1000 DARLEY AVE**

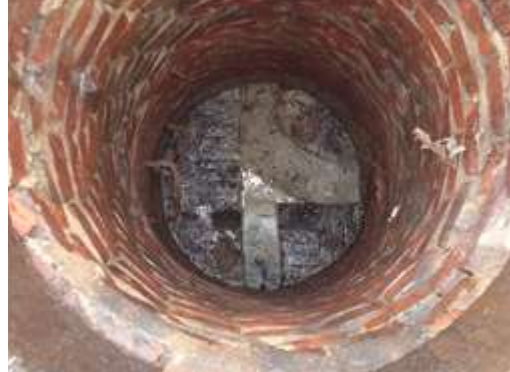
Top View

Corroded and missing steps. Bench and Channel debris.

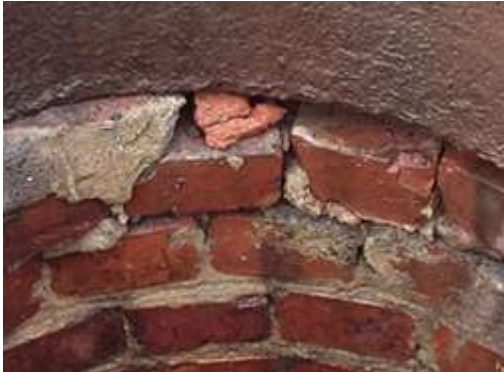
Defect

Frame leaks. Adjustment deterioration and infiltration.

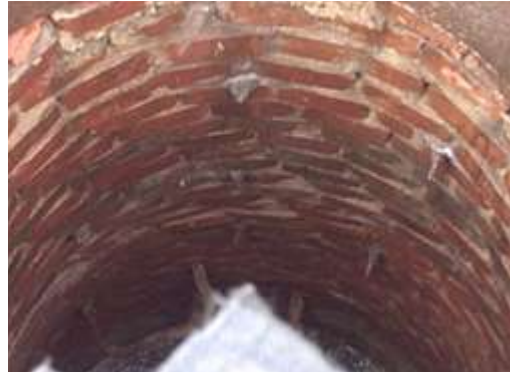
Defect

Frame leaks. Adjustment deterioration and infiltration. Corbel and Barrel infiltration.

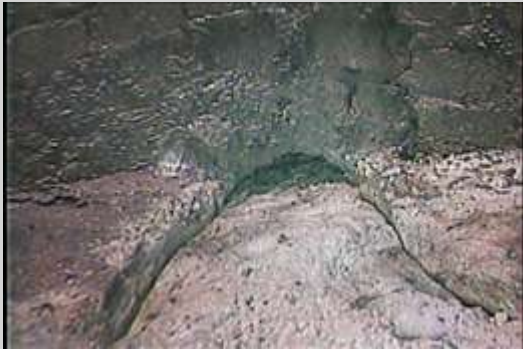
### 8 in. Circular Gravity Sewer Pipe Out @ 12 O'Clock

Deposits: ☐ None ☐ Mud ☐ Sludge ☐ Debris ☒ Grease

Silt Depth: **7** (in.) Deposits Extent: **Heavy**

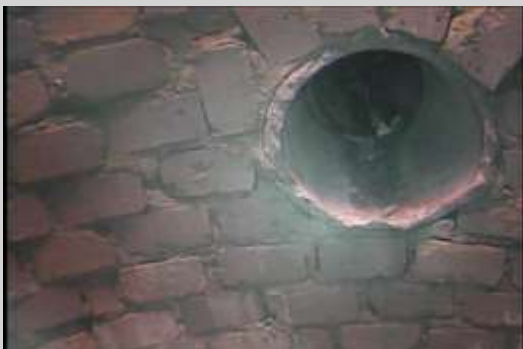
### 8 in. Circular Gravity Sewer Pipe In @ 3 O'Clock

Deposits: ☐ None ☐ Mud ☐ Sludge ☐ Debris ☒ Grease

Silt Depth: **7** (in.) Deposits Extent: **Heavy**

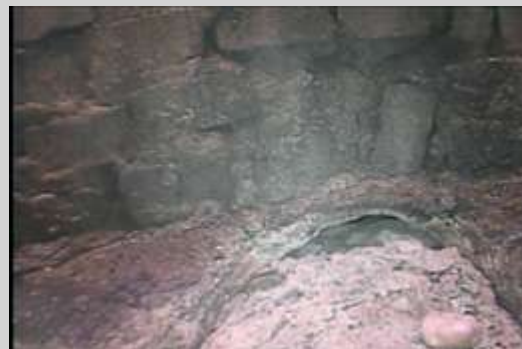
### Drop In @ 3 O'Clock

Barrel deterioration and infiltration.

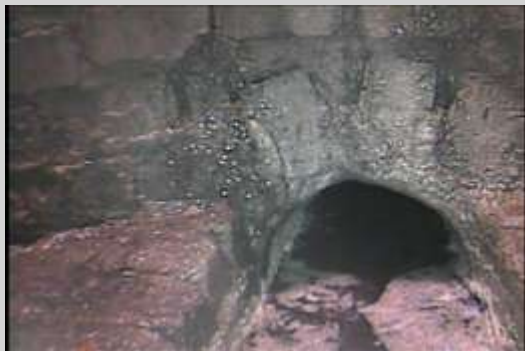
8 in. Circular Gravity Sewer  
Pipe In @ 6 O'Clock

Deposits: ☐ None ☐ Mud ☐ Sludge ☒ **Debris** ☒ **Grease**

Infiltration: **None** Pipe Seal Cond: **Broken**
